**Evaluation of Unpainted Weathering
Steel Bridges in Idaho**

**FINAL REPORT
FHWA-ITD-RP117**

Richard A. Jobes, PE

August 1, 1996

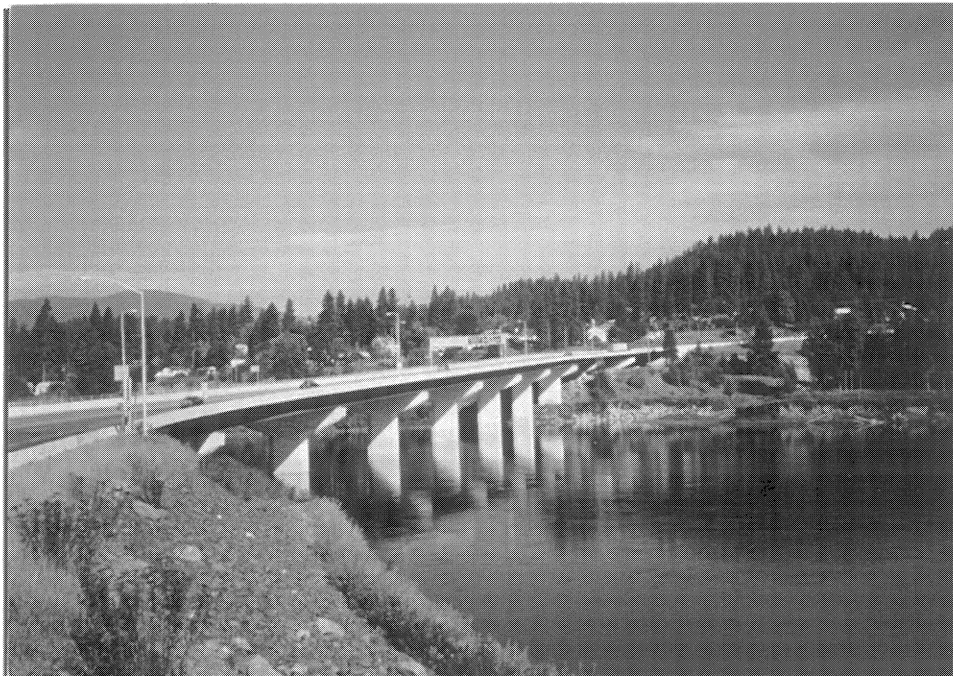
Bonniers Ferry Br.
Bridge Number
09520G 507.57

Photo No. 1
View of upstream side
from south approach

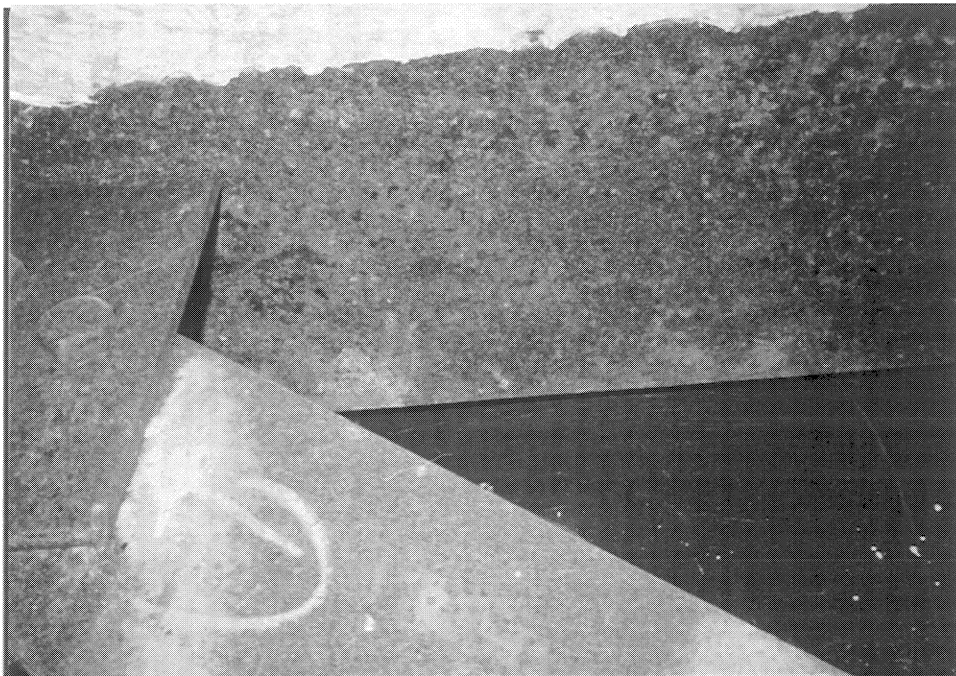
Bonnars Ferry Br.
Bridge Number
09520G 507.57

Photo No. 4
View looking up at deck
expansion joint support
beams.

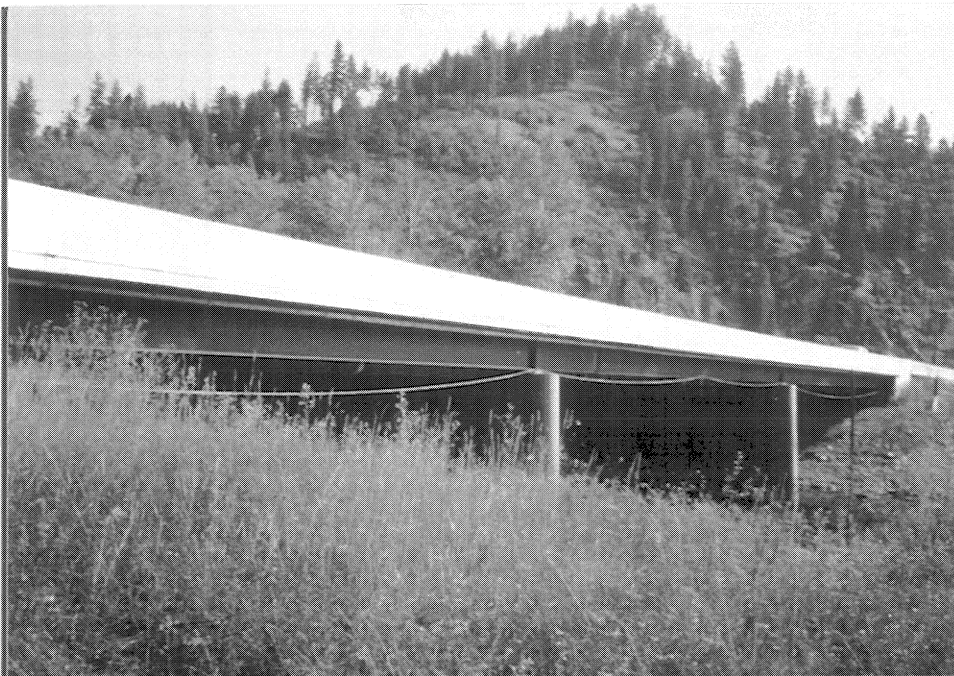
St. Maries Br.
Bridge Number
00300A 84.19

Photo No. 7
View of south side of
bridge.

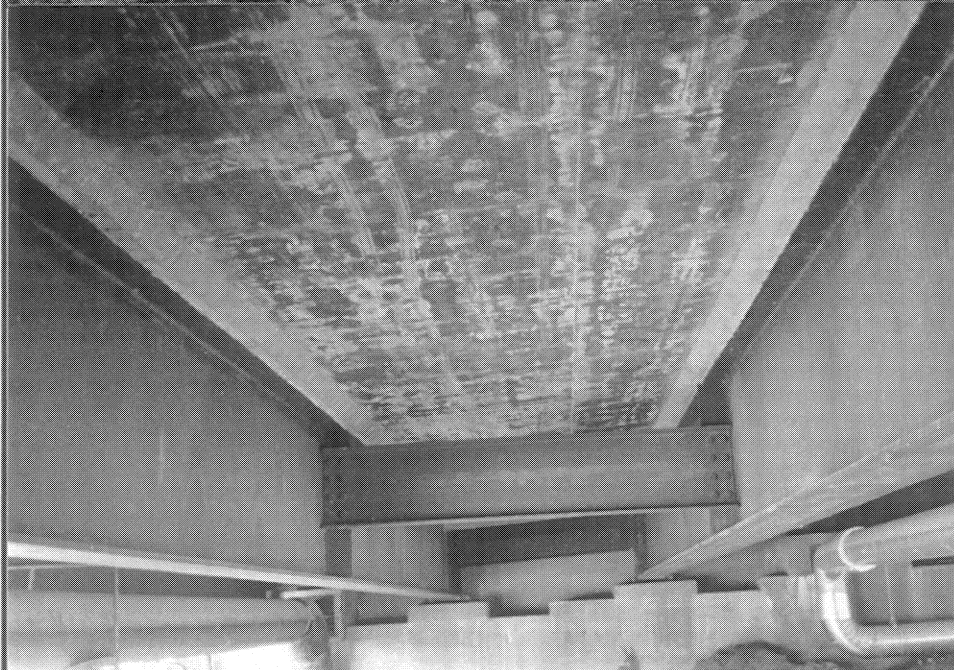
Photo No. 8
View of underside of
deck and interior faces of
interior beams.

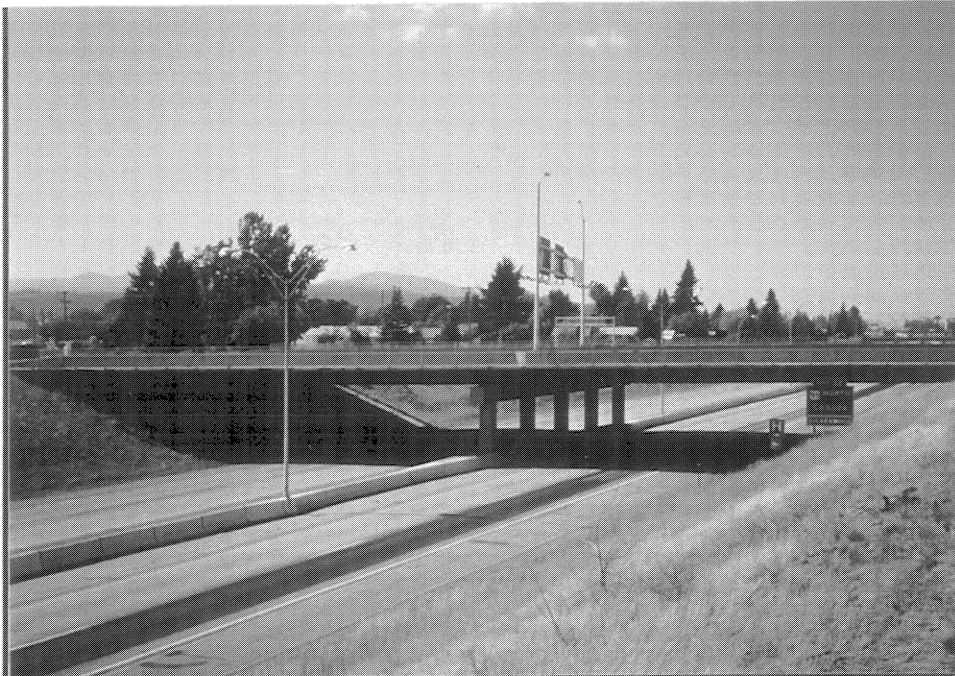
Fourth Street Br.
Bridge Number
97195A 1.63

Photo No. 13
View from East Side
looking west.

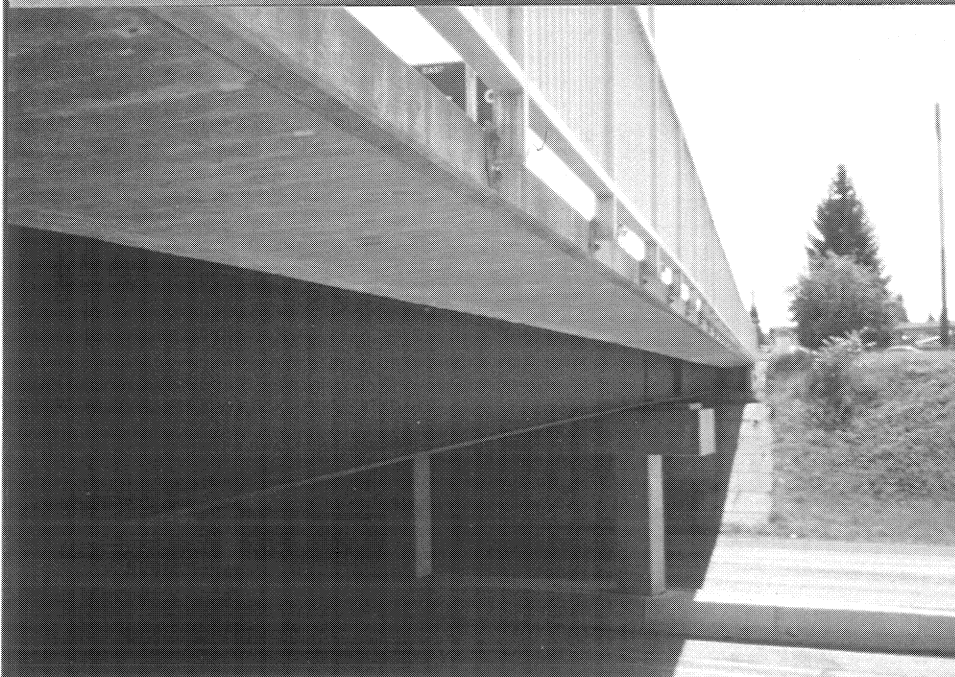
Photo No. 15
View of west exterior
girder and overhang.

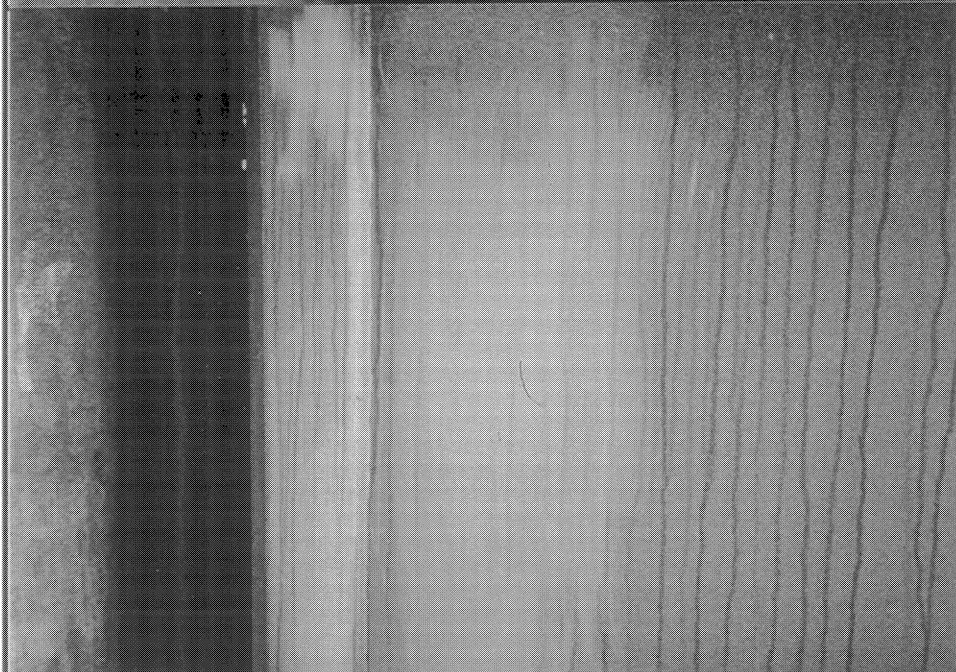
Photo No. 17

View of east exterior
girder at South Abutment
after brushing with wire
brush.

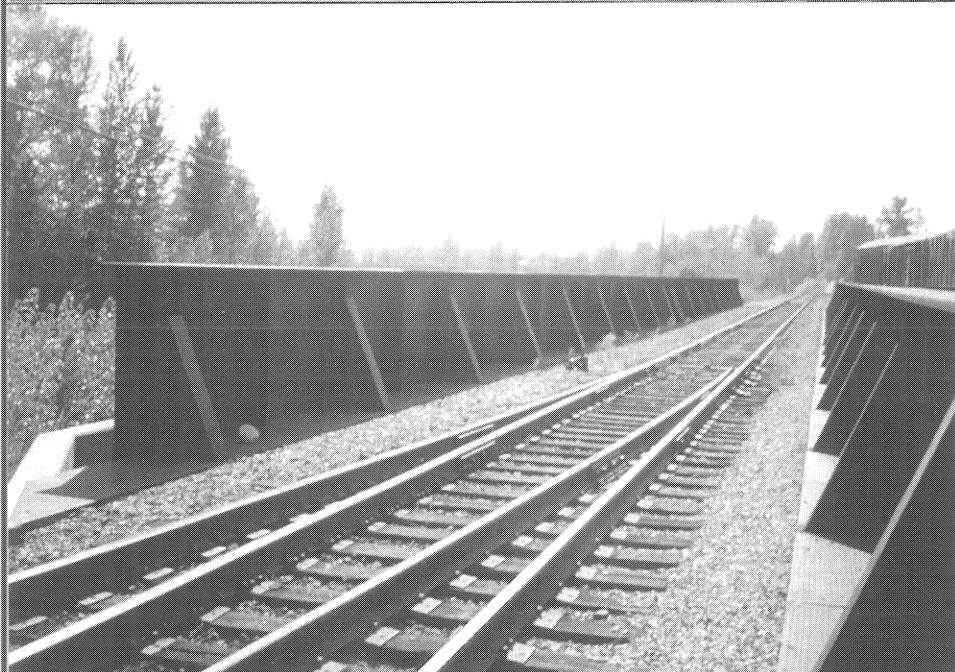
Photo No. 20
Top view of mainline
tracks looking west.

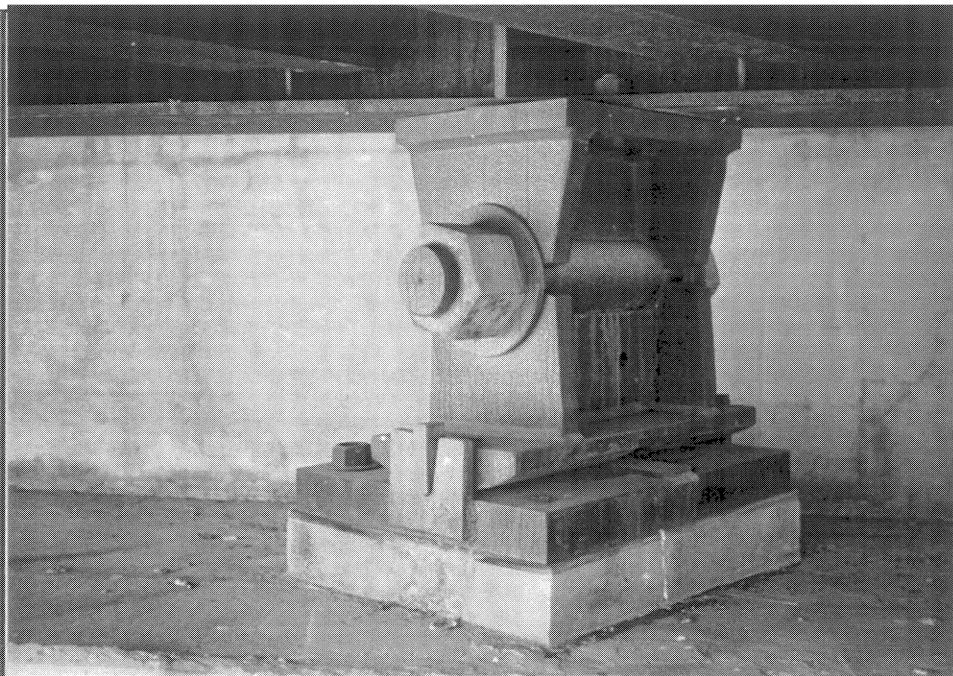
Ponderay Underpass
Bridge Number
995090 476.02

Photo No. 22
Floor beam weathering
steel bearing at abutment.

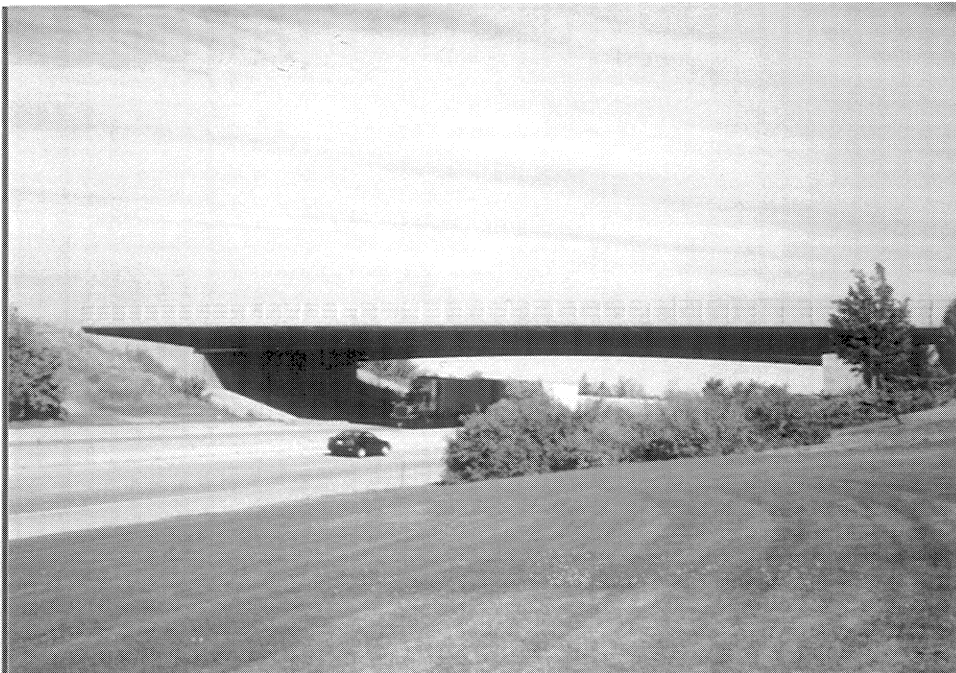
NW Caldwell IC
Bridge Number
08400B 0.89

Photo No. 25
Elevation view looking
north.

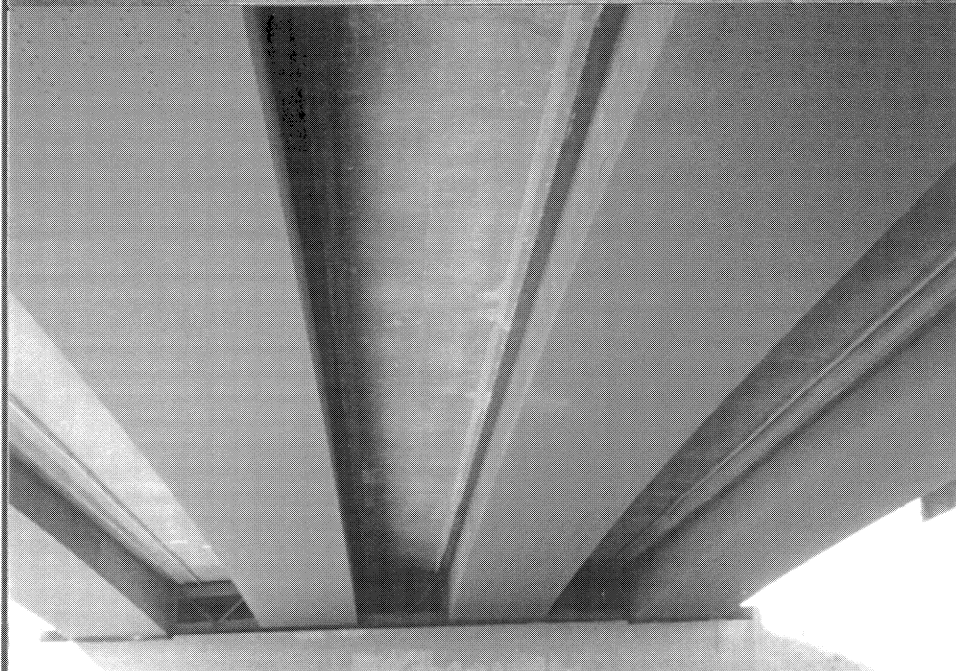
Photo No. 26
Bottom view of deck and
box girders.

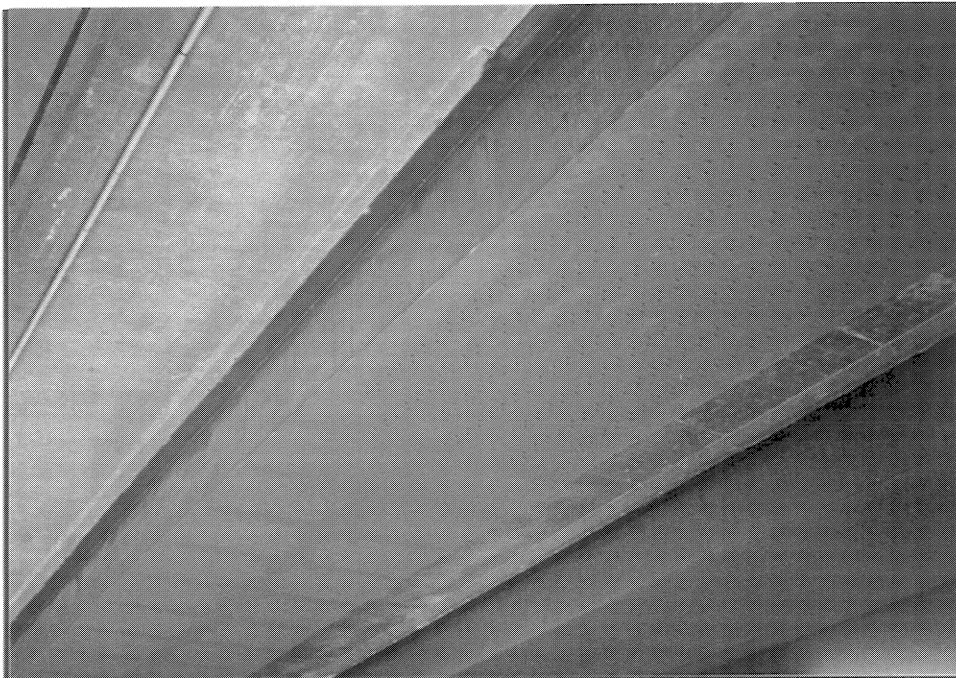
NW Caldwell IC
Bridge Number
08400B 0.89

Photo No. 28
Bottom view of bottom
flange and deck slab.

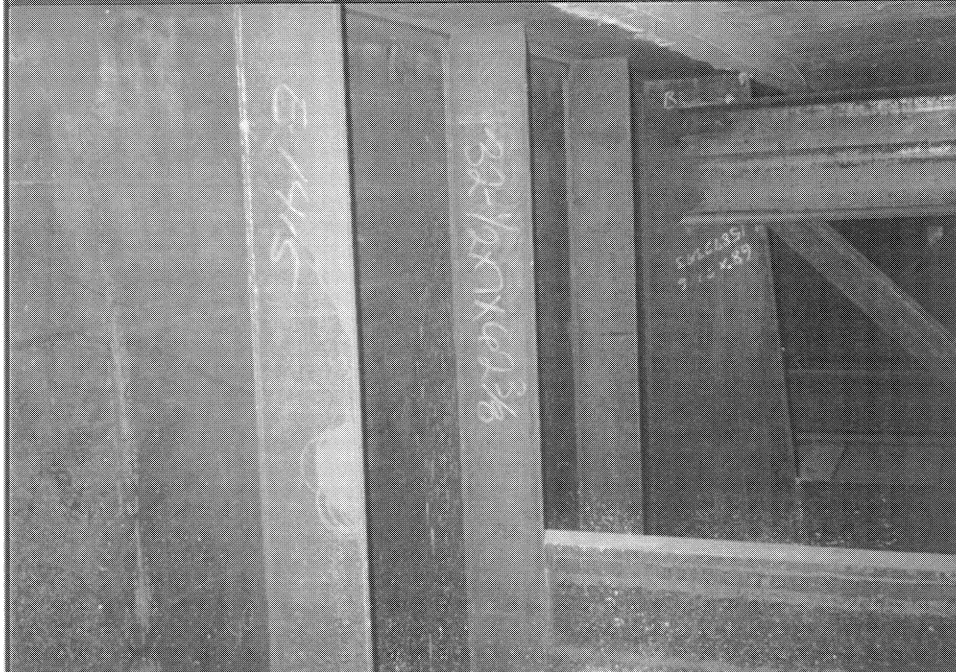
Photo No. 29
Interior of south exterior
box girder in Span 3
showing web, web
stiffeners and cross
frame.

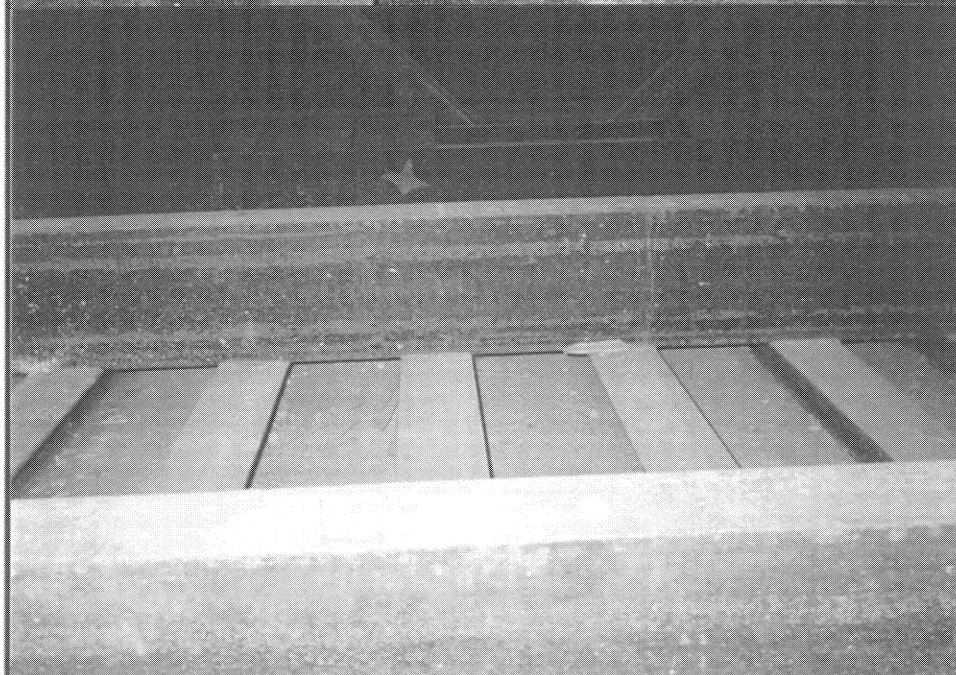
Photo No. 30
Interior of south box
girder showing bottom
flange stiffeners.

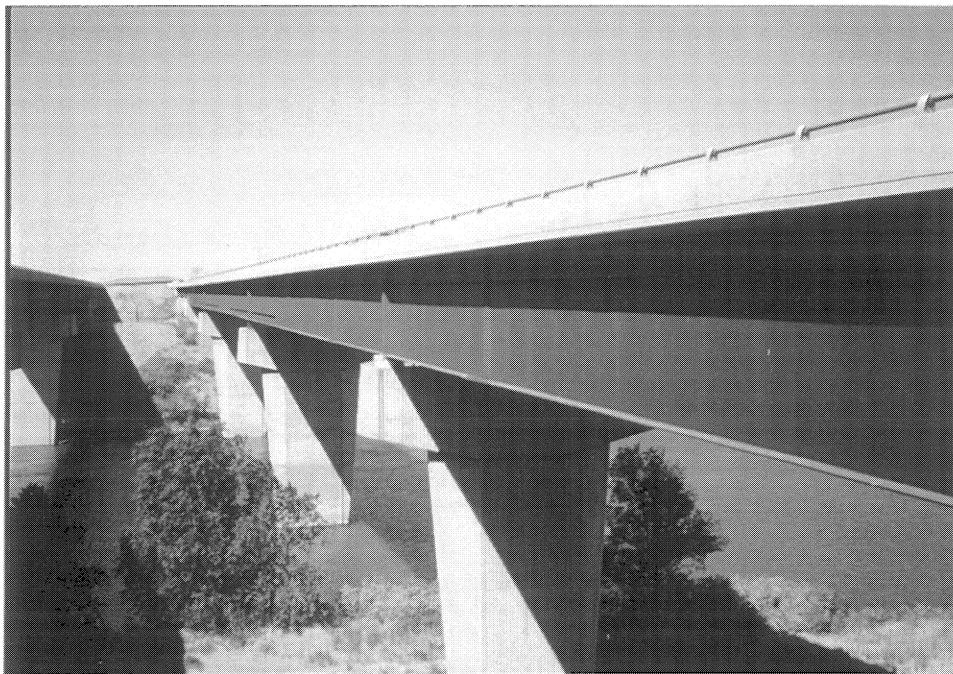
Glenns Ferry Br.
Bridge Number
08070C 121.61

Photo No. 31
View of south exterior
girder from East
Abutment.

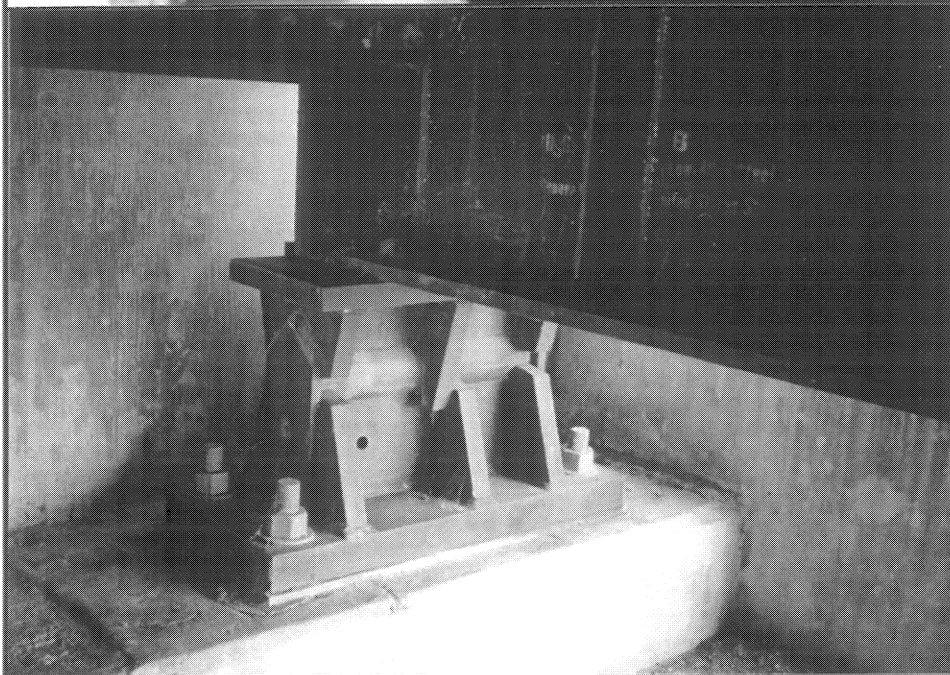
Photo No. 36

Weathering steel fixed
bearing at West
Abutment.

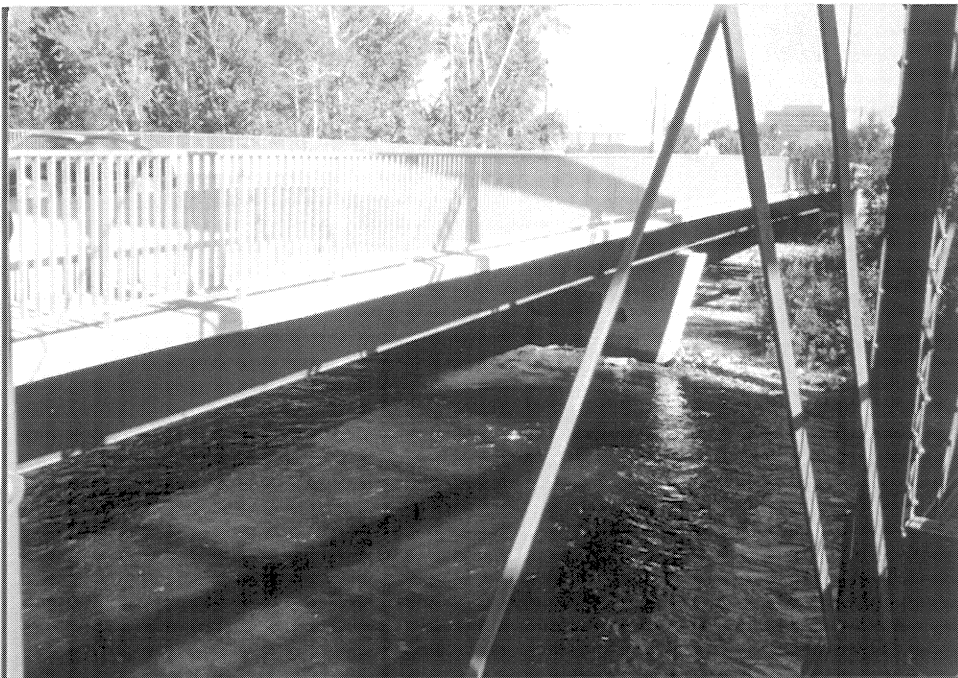
South Ninth St. Br.
Bridge Number
97553A 0.20

Photo No. 37
View of East Side of
bridge from adjacent
pedestrian bridge near
South Abutment

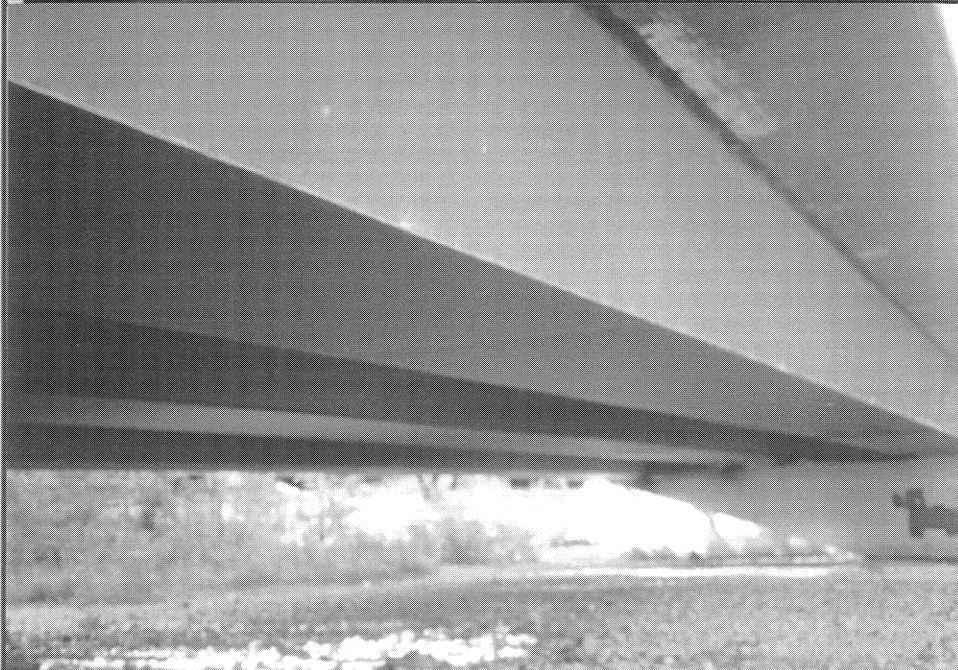
Photo No. 38
View of girders in Span 2
from West Side near
North Abutment

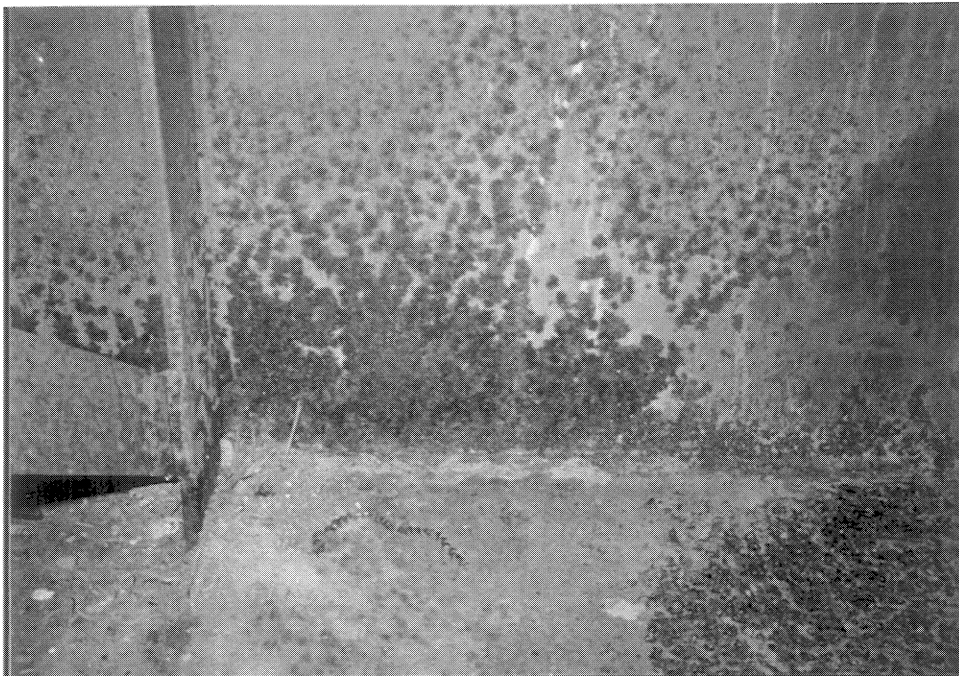
South Ninth St. Br.
Bridge Number
97553A 0.20

Photo No. 40
Inside view of east box
girder at first diaphragm
from North Abutment.

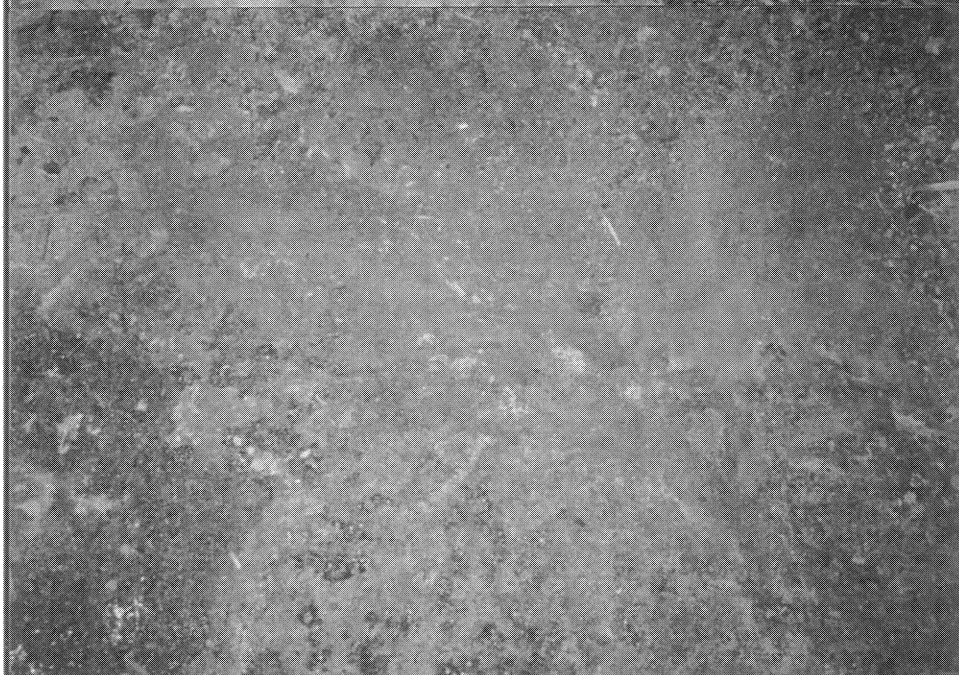
Photo No. 41
Inside view of east box
girder bottom flange near
North Abutment.

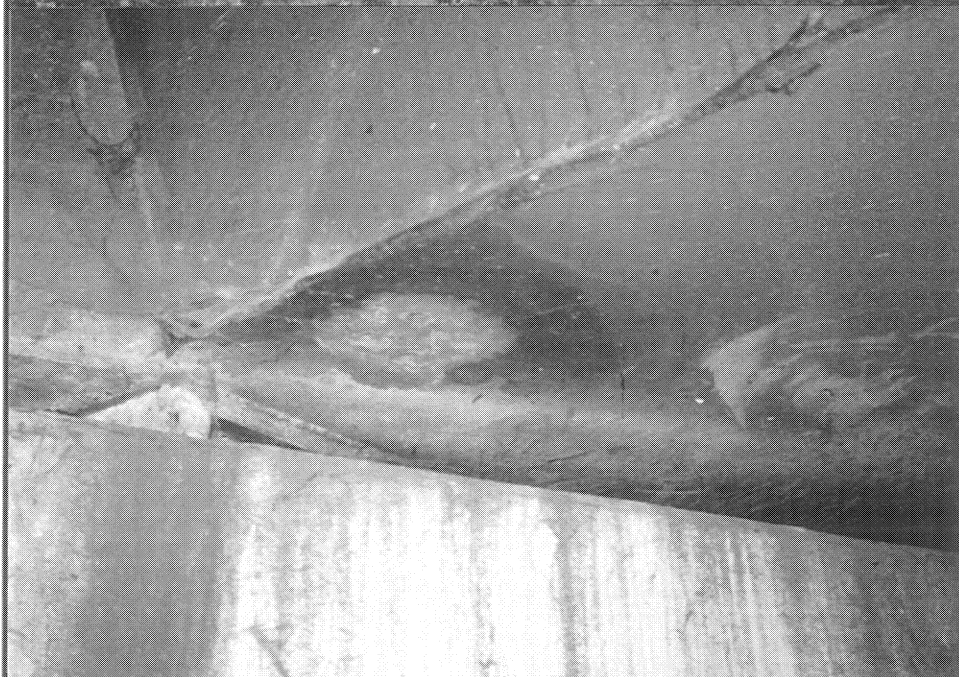
Photo No. 42
Exterior view of drain
holes in bottom flange at
North Abutment.

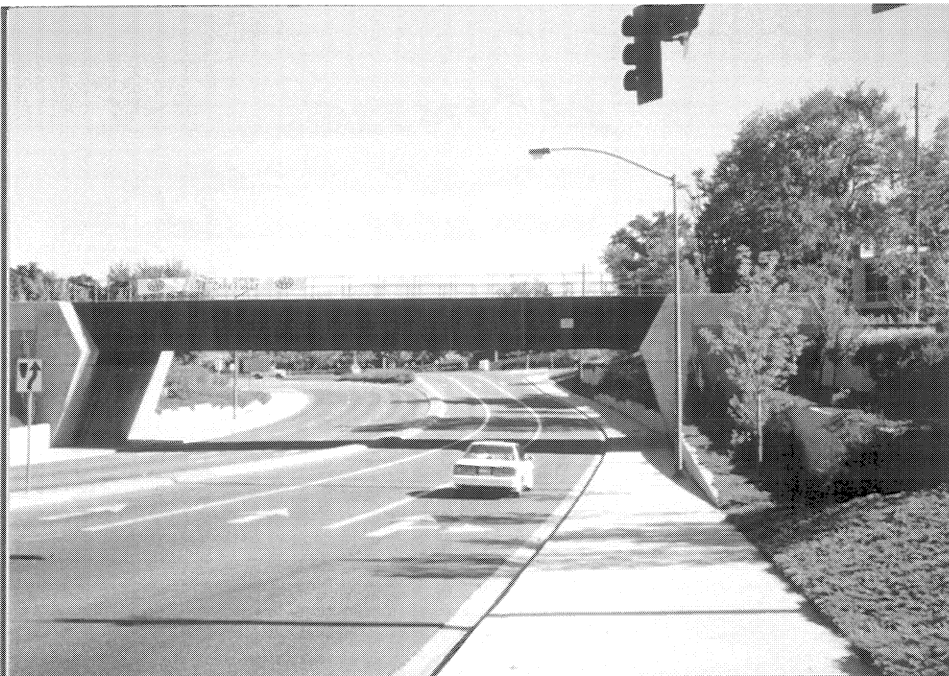
Vista Underpass.
Bridge Number
97433A 9.96

Photo No. 43
Elevation view looking
north.

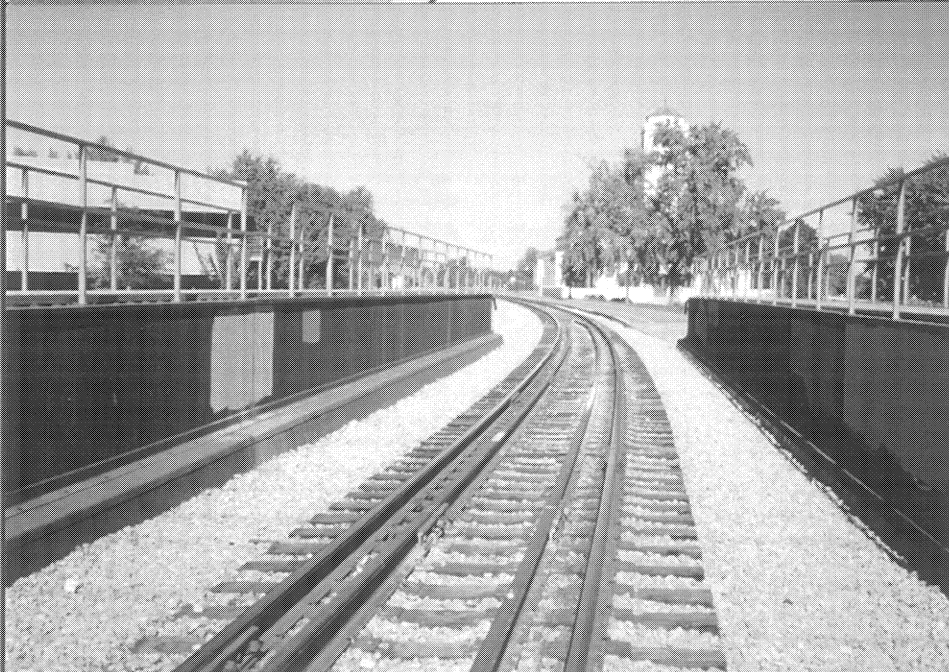
Photo No. 44
Top view looking west,
showing tracks and
ballast. Note the paint
patches covering grafitti.

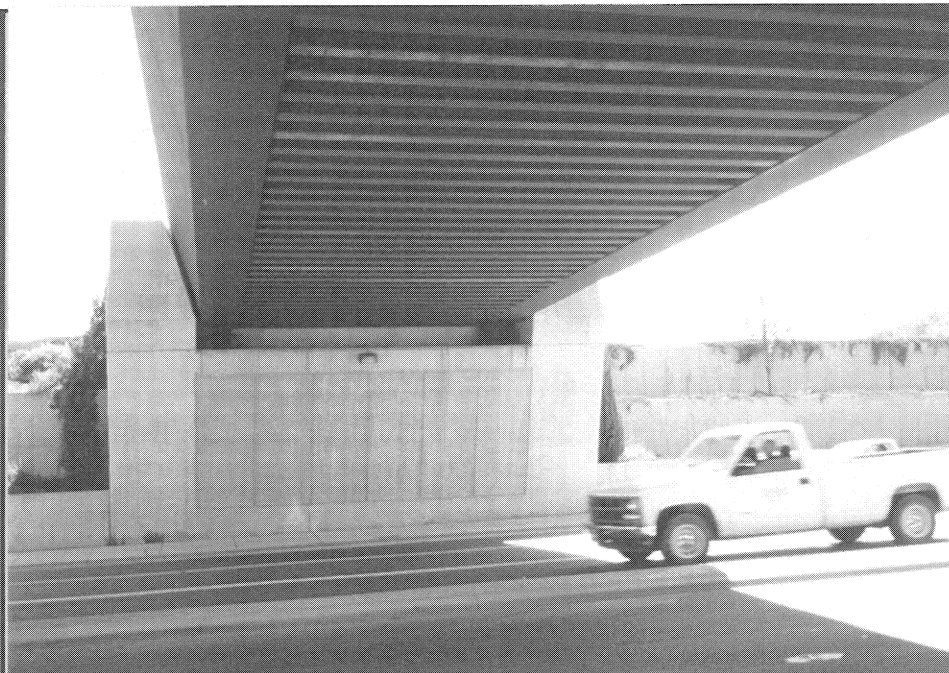
Vista Underpass.
Bridge Number
97433A 9.96

Photo No. 46
Elevation view of East
Abutment and bottom of
superstructure.

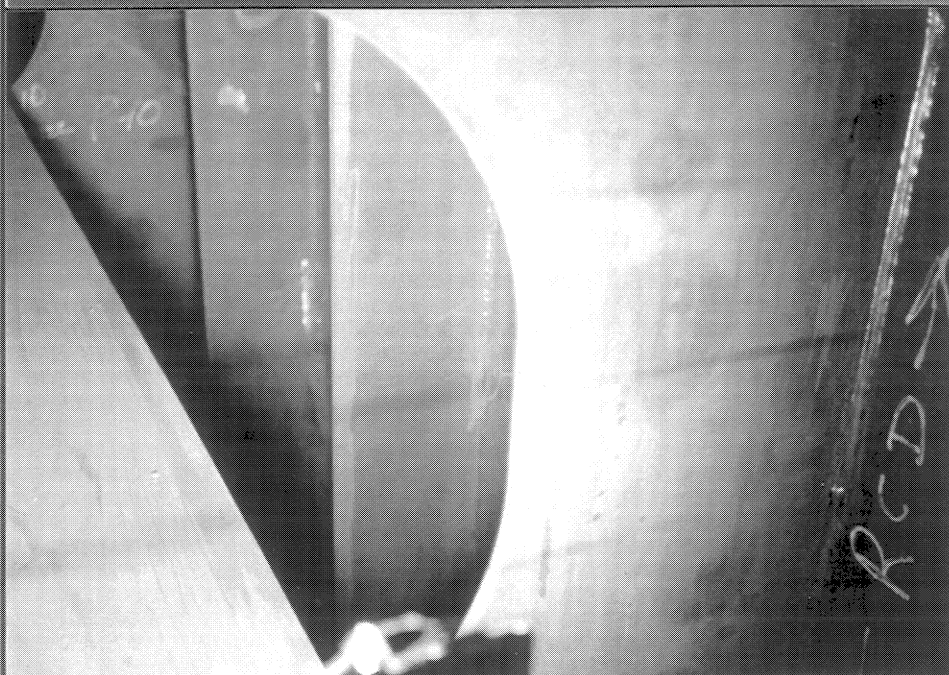
Photo No. 47
Interior of south box at
East Abutment, showing
web stiffeners and plate
diaphragms with access
hole.

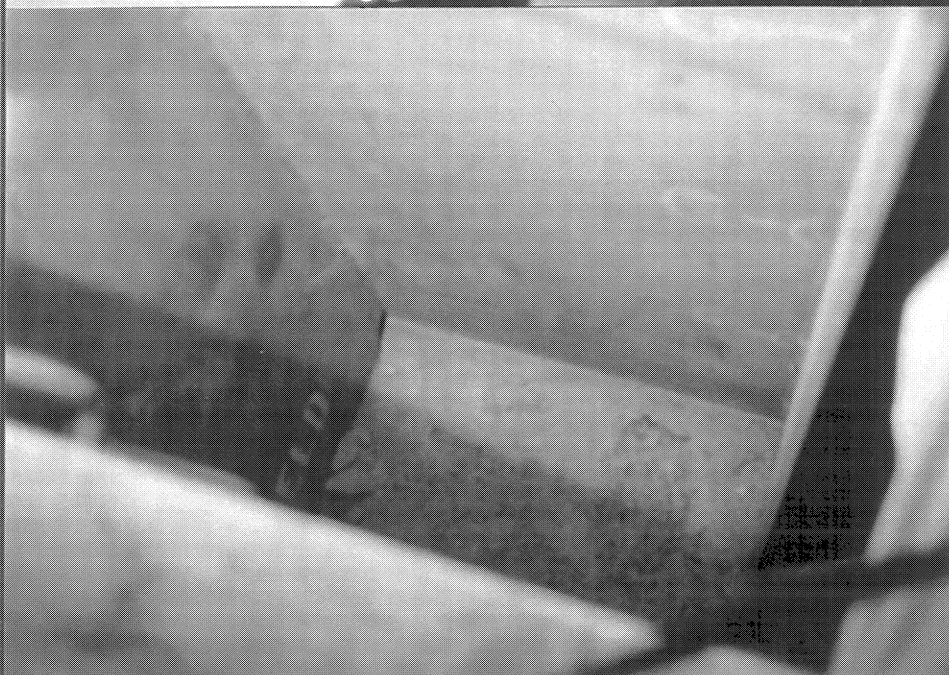
Photo No. 48
Interior of south box
looking down on bottom
flange.

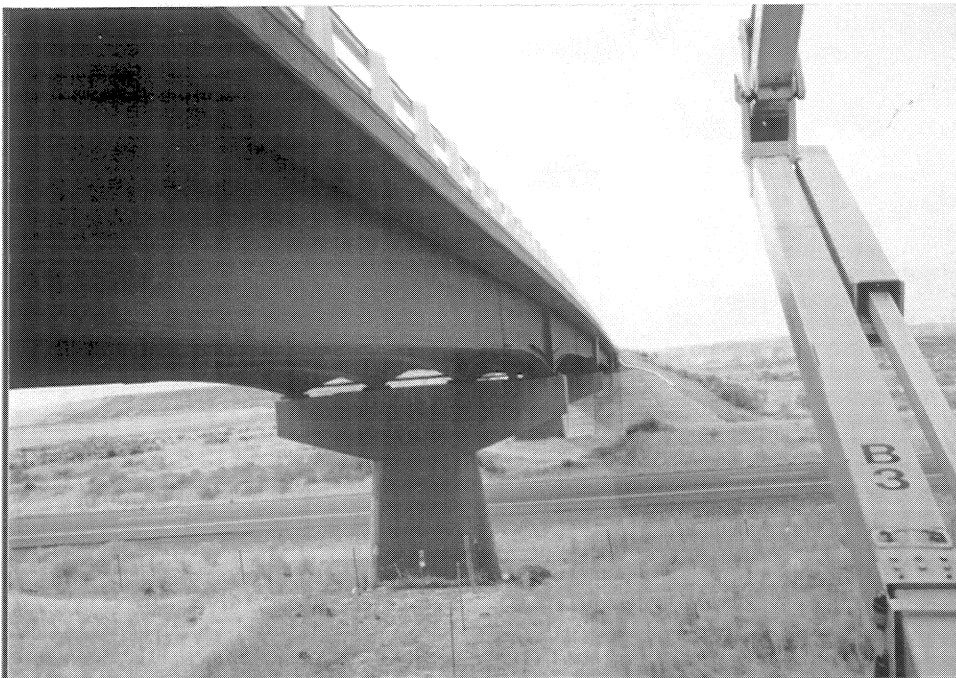
Grade Separation #1
Bridge Number
08070D 143.53

Photo No. 49
View of west girder from
North Abutment

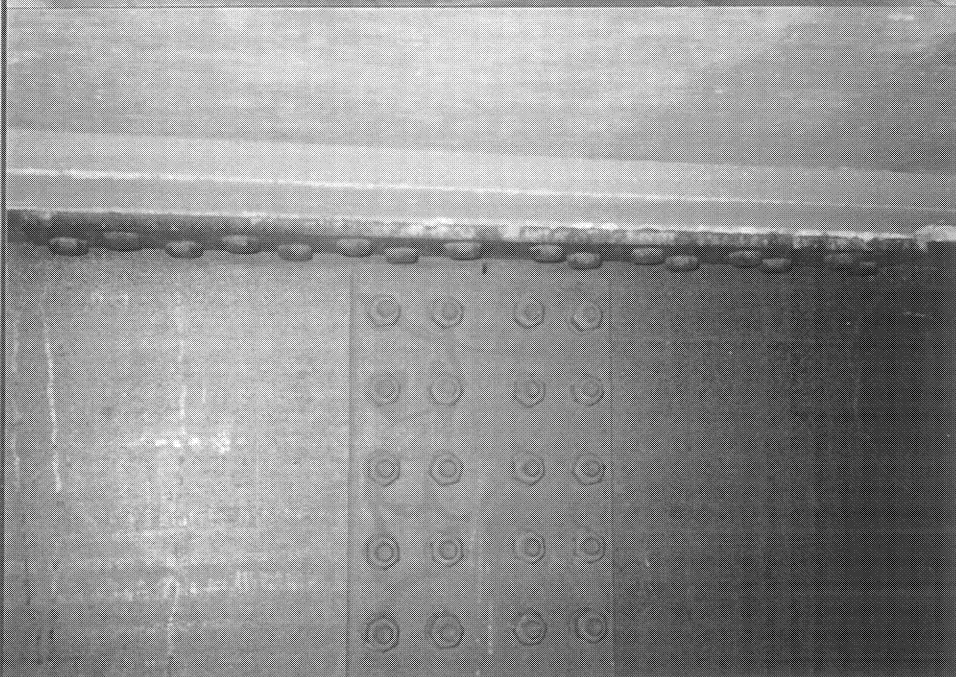
Photo No. 51
View of interior girder
field splice.

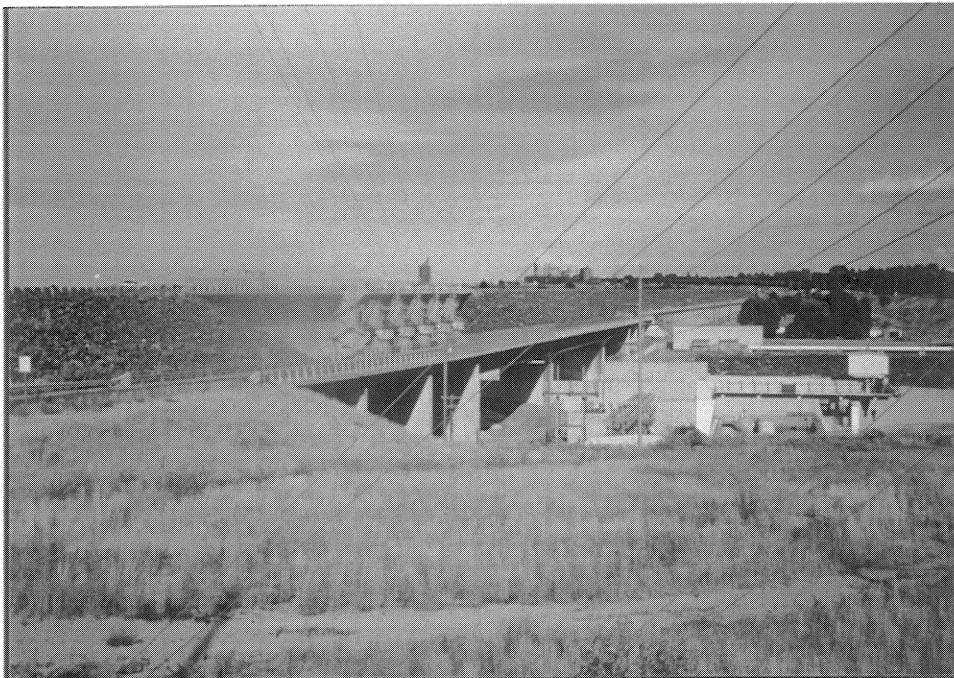
American Falls Br.
Bridge Number
03910A 2.62

Photo No. 55
View of bridge looking
east. Note dam just
above bridge and power
plant just below bridge.

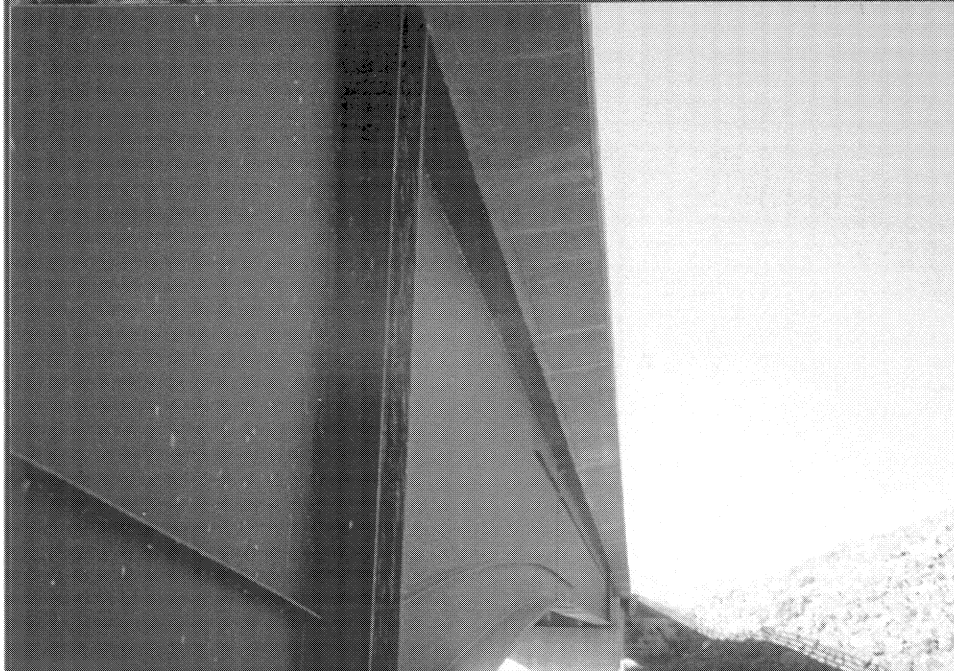
Photo No. 56
View of south main span
girder looking east.

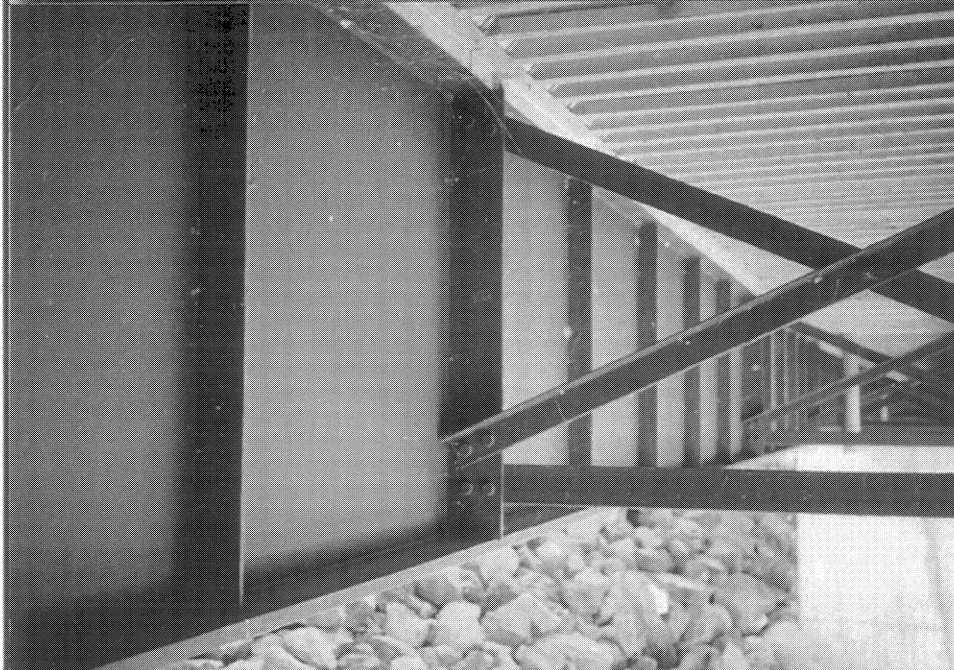
Photo No. 59

Interior view of north
exterior girder and cross
frames at Span 3. Note
the metal forms.

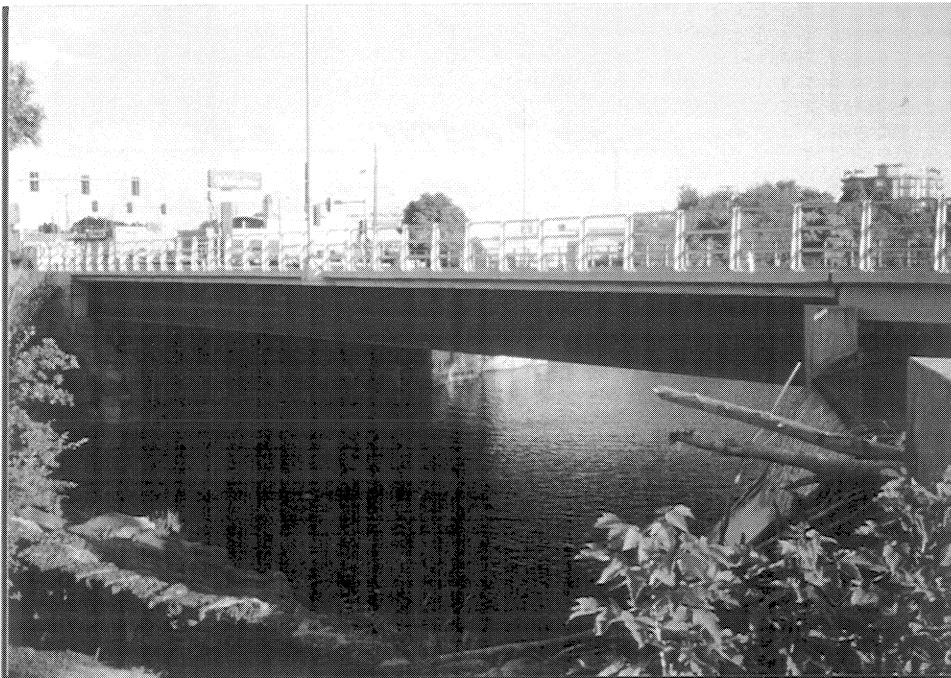
Broadway Bridge
Bridge Number
015711 6.59

Photo No. 61
View of south side of
steel span.

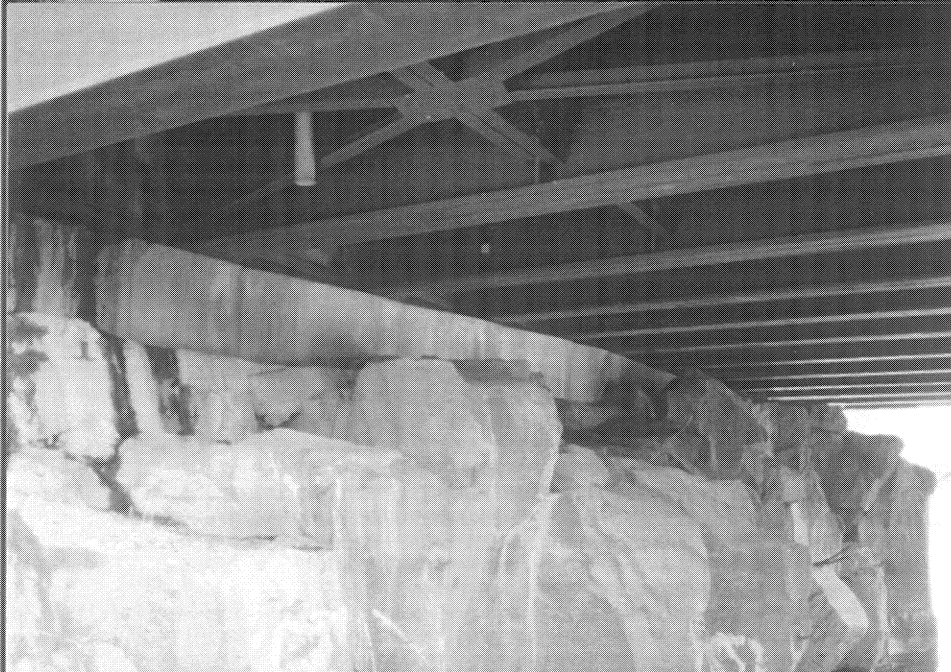
Photo No. 62
View of West Abutment
from river.

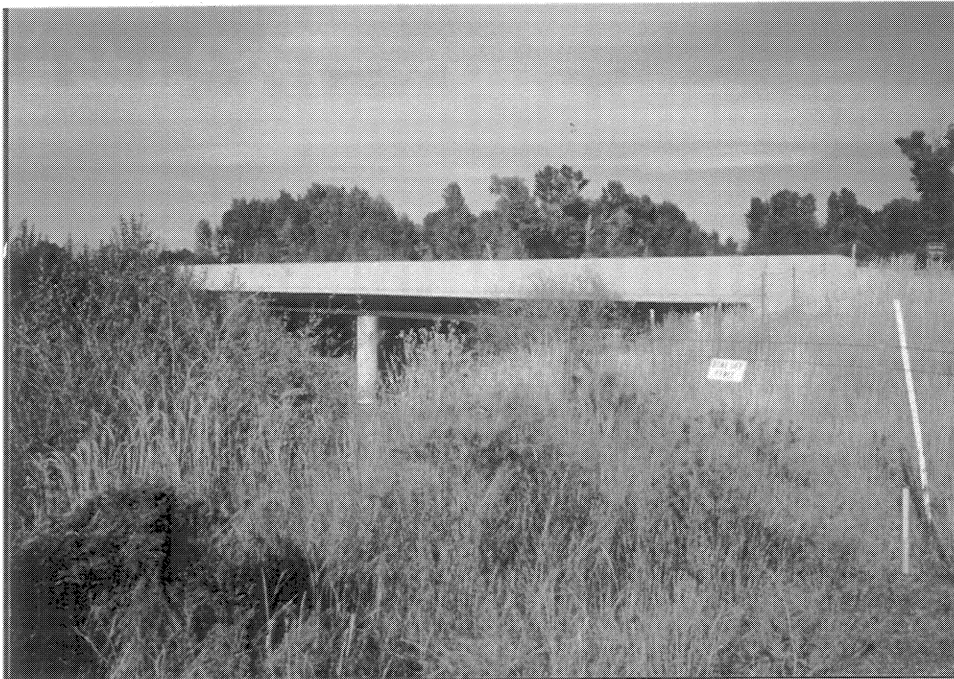
Teton River Br.
Bridge Number
02020K 334.44

Photo No. 66
View of West Side of the
bridge from the south
bank.
